Boring the world's
longest tunnels:
innovation at work

Classification of tunnels

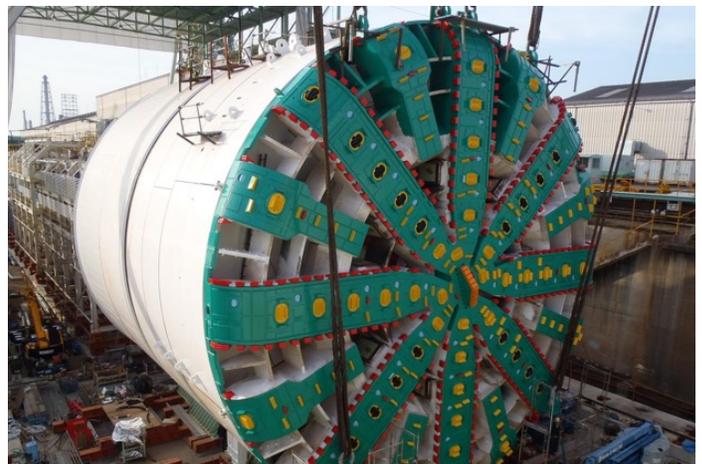
Pictured is a TBM called Bertha, the largest TBM ever built (57.5 ft.). Bertha completed boring Seattle's State Route 99 tunnel in April 2017.

- **Boring:** A system that cuts through rock with a rotating head (or cutterhead) mounted with disc cutters. As the cutterhead rotates, it presses the discs against its face, which creates a slicing motion. The high pressure the cutterhead exerts is greater than the compressive strength of the rock, and that is how it grinds it fairly easily.

In 2013, Hitachi Zosen Sakai Works delivered Bertha, at the time the world's largest tunnel boring machine named after Seattle's only female mayor, Bertha Landes. Three days after the TBM started the \$1.35 billion boring project, Bertha ground to a halt. An investigation revealed that its seals and bearings were damaged from overheating. Recovery efforts led to \$500 million in additional costs, and repairs took two years to complete. While the added costs and repair timeline made headlines, the rest of the story is far more intriguing.

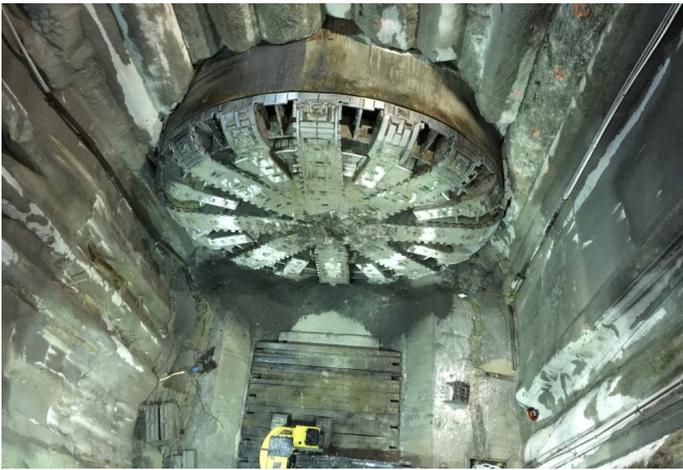
Pictured is a pit that was dug to perform repairs on Bertha.

Bertha's problems began when the TBM hit a 120-foot-long, 8-inch-diameter steel well casing. Casing is a tubular structure that is placed in a drilled well to maintain the well opening. The casing also holds back unstable earth materials, preventing them from collapsing into the well. Some experts opined that Bertha was not powerful enough, until Hitachi Zosen made some modifications during the shutdown. Seattle Business Magazine published the firsthand experience of two workers who adamantly disagreed with allegations that Bertha was underpowered and too large to control.

The operators increased Bertha's thrust to 325,000 kilonewtons, over three times the maximum specified. To put this in perspective, this thrust is approximately 9 times greater than the thrust required to launch a space shuttle. The TBM began to overheat and a safety feature automatically shut it down to protect its critical seals and bearings. Once cooled, the operators pushed Bertha again and again; it is believed that the cycled overheating is what damaged the TBM so severely.
